**IN RE: ETHICON, INC., PELVIC REPAIR
SYSTEM PRODUCTS LIABILITY
LITIGATION**

Master File No. 2:12-MD-02327

RULE 26 EXPERT REPORT OF HOWARD JORDI, PhD

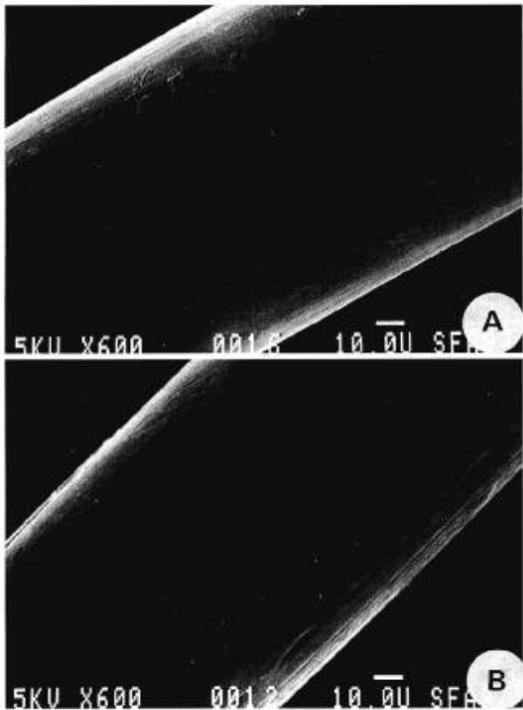
Figure 6. Scanning electron photomicrographs of retrieved and cleaned 6-0 polyvinylidene fluoride sutures showing the surface morphology after implantation for 1 (A, $\times 600$) and 2 (B, $\times 600$) years *in vivo*.

After 1 and 2 years of implantation the surface of the retrieved and cleaned PVDF sutures did not appear to be substantially modified (fig 6). In contrast, the polypropylene sutures explanted 1 and 2 years postoperatively showed evidence of surface deterioration, characterized by uniformly spaced circumferential cracking and peeling and flaking of the polymer material in the outermost surface layer (fig. 7) (emphasis added)

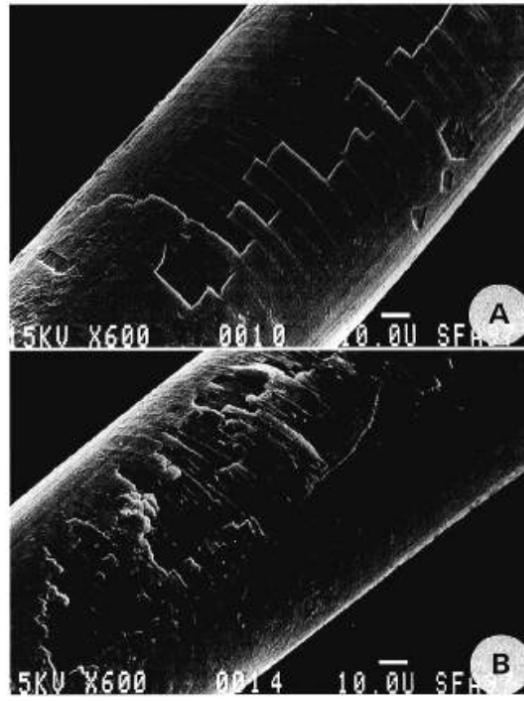
Figure 7. Scanning electron photomicrographs of retrieved and cleaned 6-0 polypropylene sutures showing the surface morphology after implantation for 1 (A, $\times 100$) and 2 (B, $\times 600$) years *in vivo*.

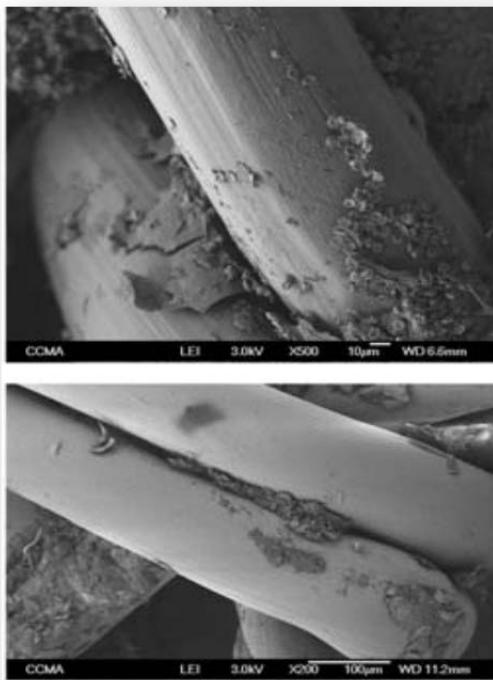
Figure 3- Scanning electron micrograph of heavy weight polypropylene from a pristine Composix E/X mesh. **Figure 6.** Scanning electron micrograph of heavy weight polypropylene from an explanted Kugel Composix mesh (specimen 2, which remained in vivo for an additional 5 months compared with specimen 1).⁴⁸

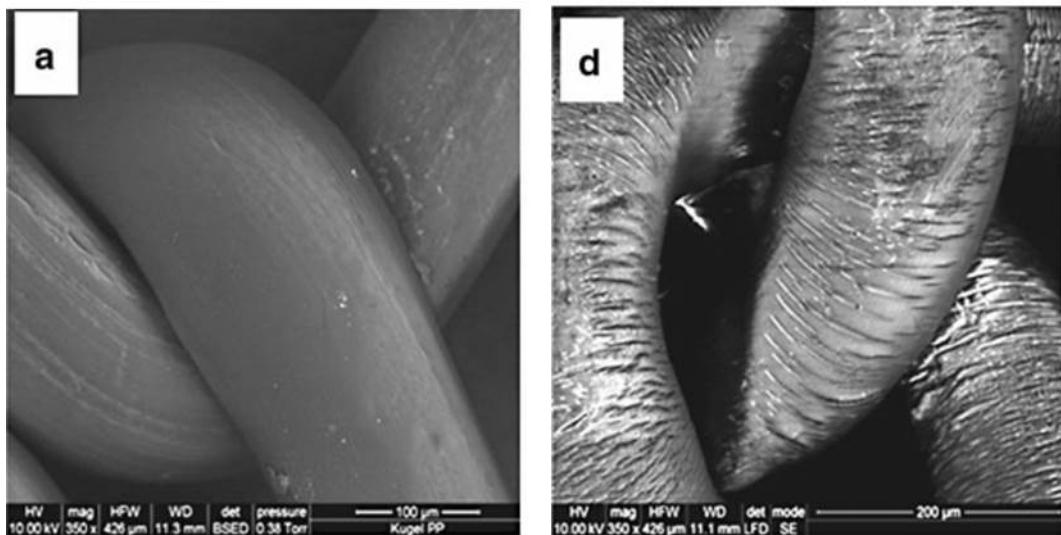
Figure 5- SEM images of pristine (a) polypropylene hernia mesh as well as explanted (d) polypropylene hernia mesh.⁵¹

To determine why the polypropylene had cracked, these scientists used FTIR. Wood *et al.* concluded that the cracked surface of the explanted polypropylene mesh was caused by oxidative degradation as confirmed by the presence of a carbonyl band at $\sim 1740 \text{ cm}^{-1}$:

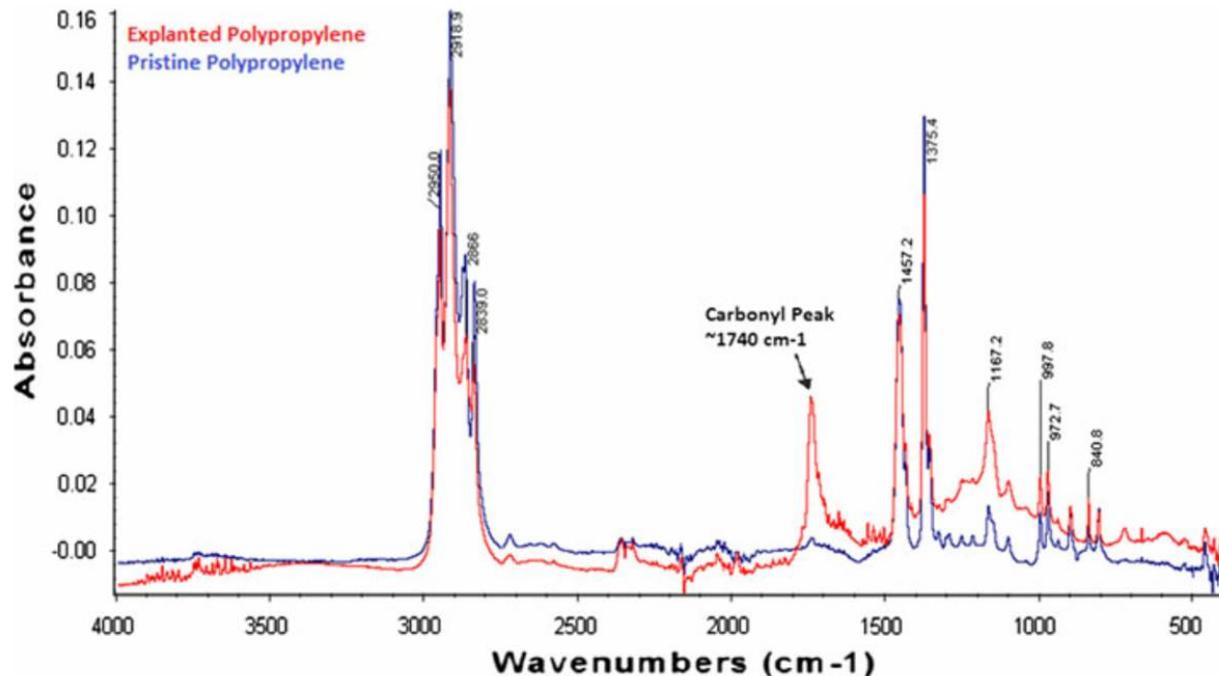
Figure 6- ATR-FTIR scans of pristine polypropylene and a representative polypropylene explant illustrating the carbonyl ($\text{C}=\text{O}$) peak.⁵²

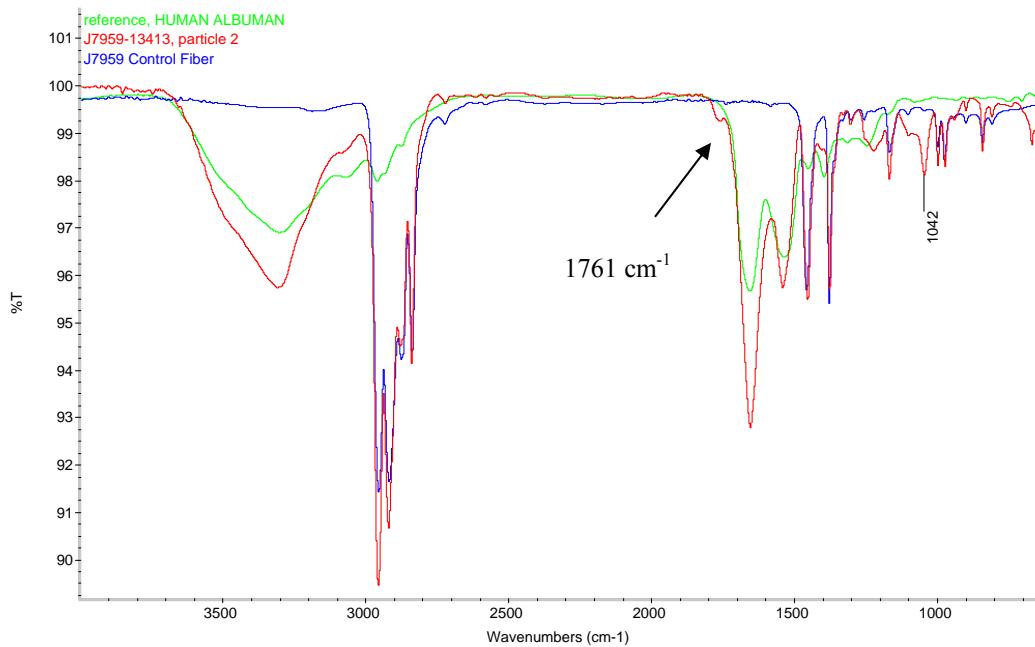
Similar to the FTIR findings in the Wood article, I have also found evidence that the Prolene in the TTV devices oxidizes which is the likely cause of the degradation and cracking observed on explanted TTV devices:

Figure 7- Overlay of FTIR spectra observed by me for explant sample 13413 particle 2 (red), human albumin (green) and control fiber lot 3422128 (blue).

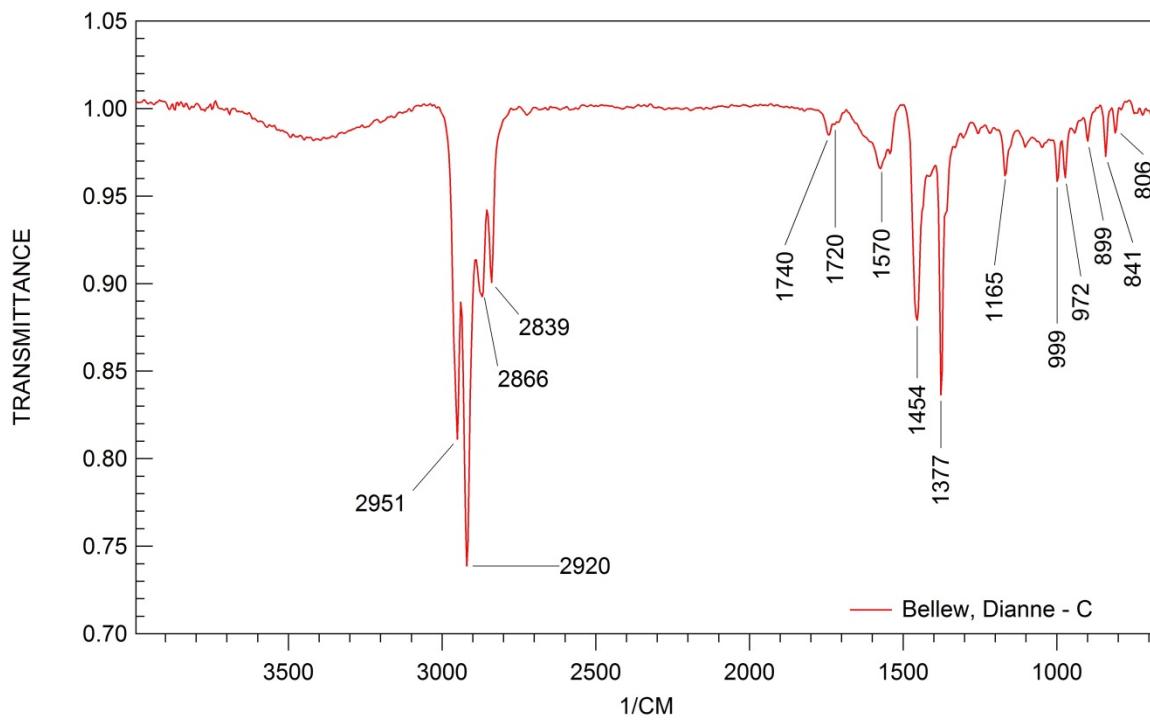
Figure 8: FTIR spectrum from an explanted Ethicon Prolift device which is also manufactured using Ethicon's Prolene polypropylene material – the same Prolene material used in Ethicon's Prosima and TVT devices (sample 35615 - C).

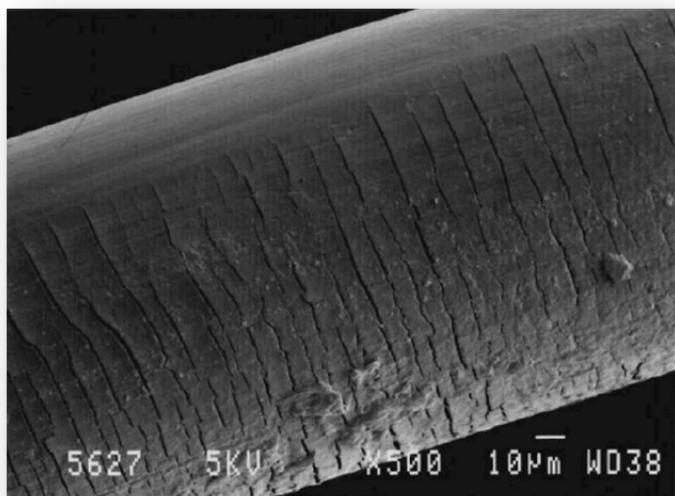
Figure 9- SEM image of suture explanted from a dog by Ethicon.

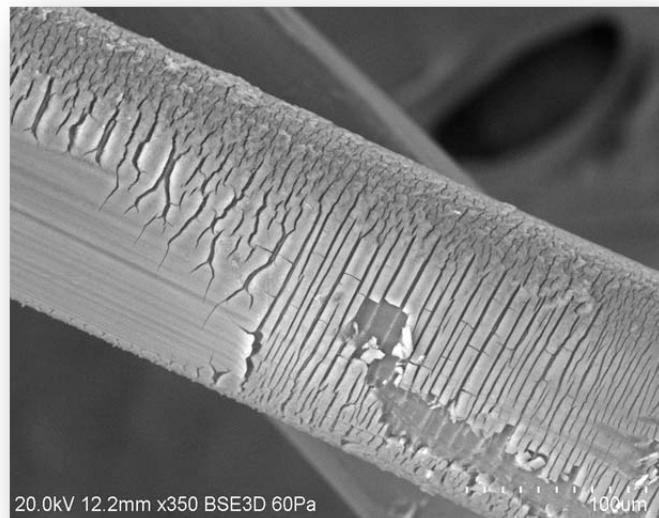
Figure 10- SEM image of explanted TTV device (Sample J7959 A13418)

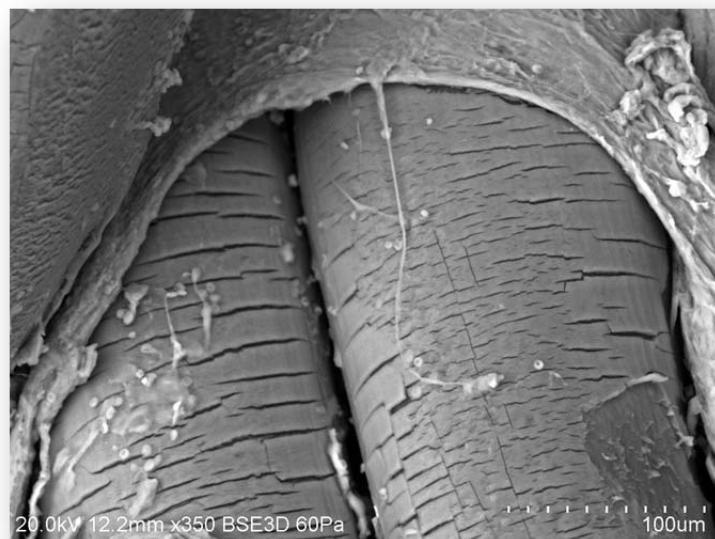
Figure 11- SEM image of explanted TTV device (Sample J7959 13405)

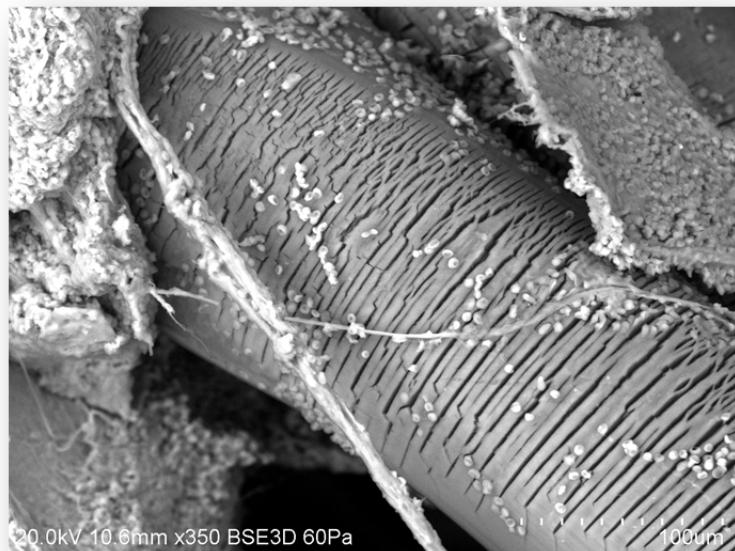
Figure 12- SEM image of explanted TTV device (Sample J7959 13407)

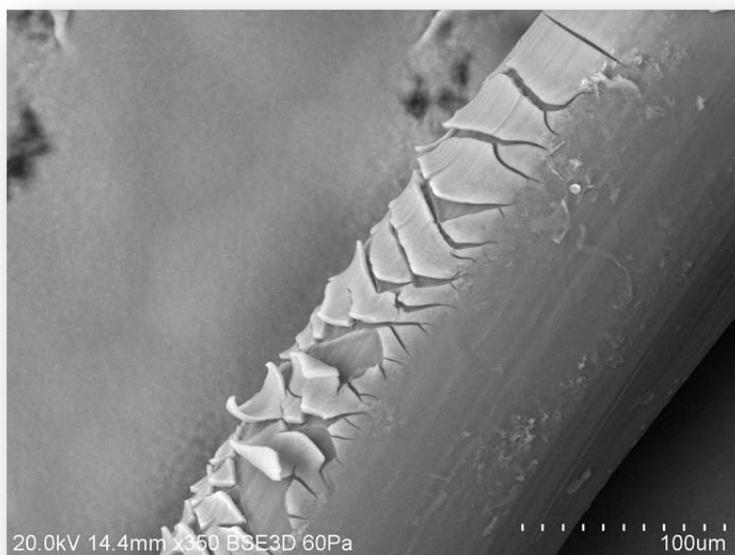
Figure 13- SEM image of explanted TTV device (Sample J7959 13403)

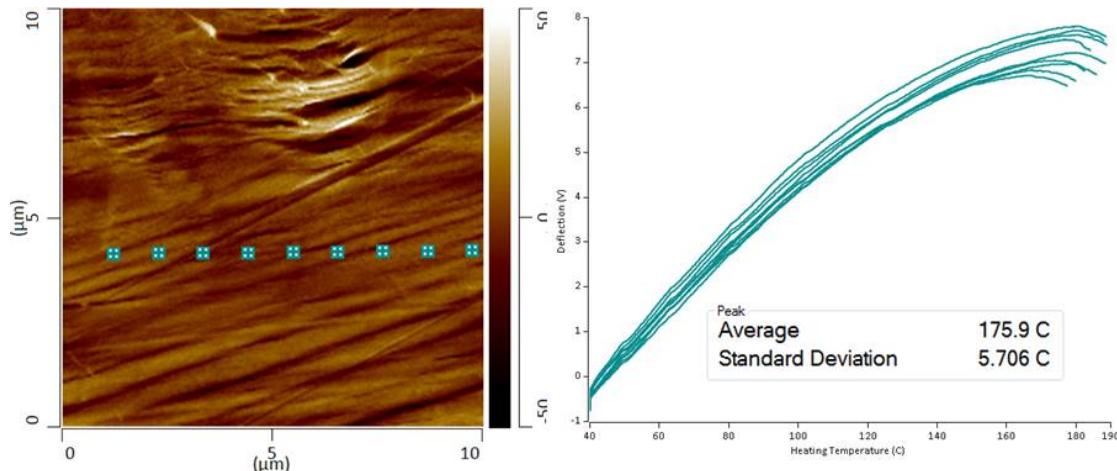
Figure 15 - AFM height image of sample surface of Exemplar A (left). nanoTA measurements obtained from surface of Exemplar A (right).

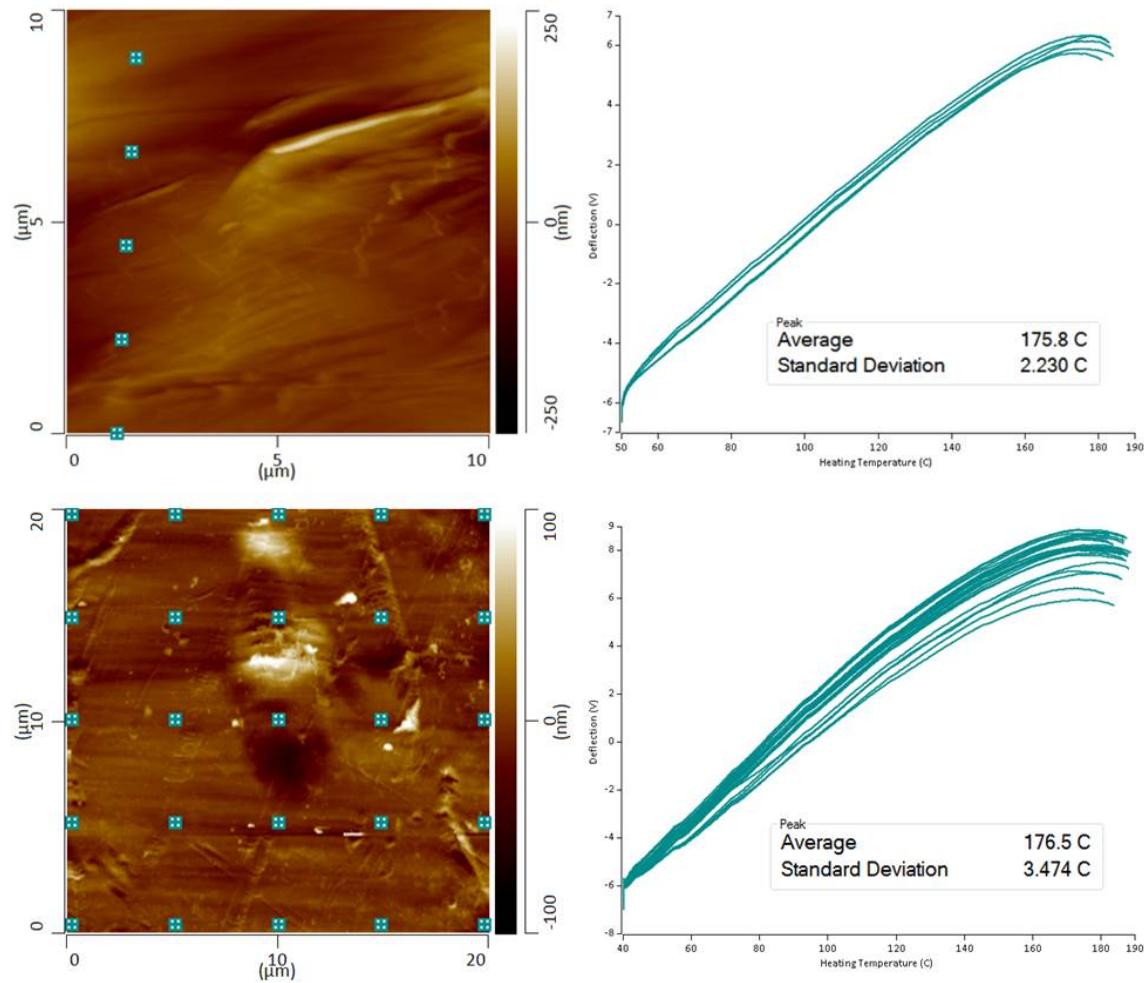
Figure 16 - AFM imaging of Exemplar C (markers on image indicate regions for subsequent nanoTA measurements (left). nanoTA measurements obtained on the surface of Exemplar C (right).

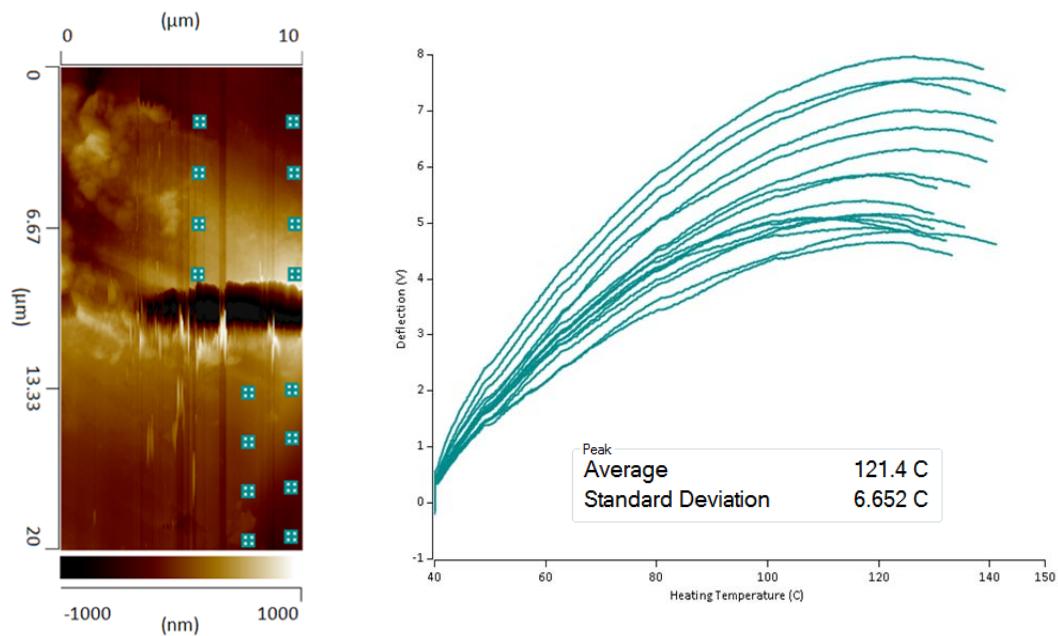
Ethicon's findings above are consistent with my own experience using melt point methods to analyze explanted Ethicon Prolene mesh devices. I have observed lower melt points using Nanothermal analysis which demonstrated that the explanted device degraded as a result of oxidation, which most likely occurred as a result of *in vivo* leaching of the antioxidants which leaves the Prolene fibers unprotected against oxidation.

Figure 17 - AFM image of cracked region on Bellew, Dianne B (left). nanoTA measurements obtained around cracked regions on Bellew, Dianne B (right).

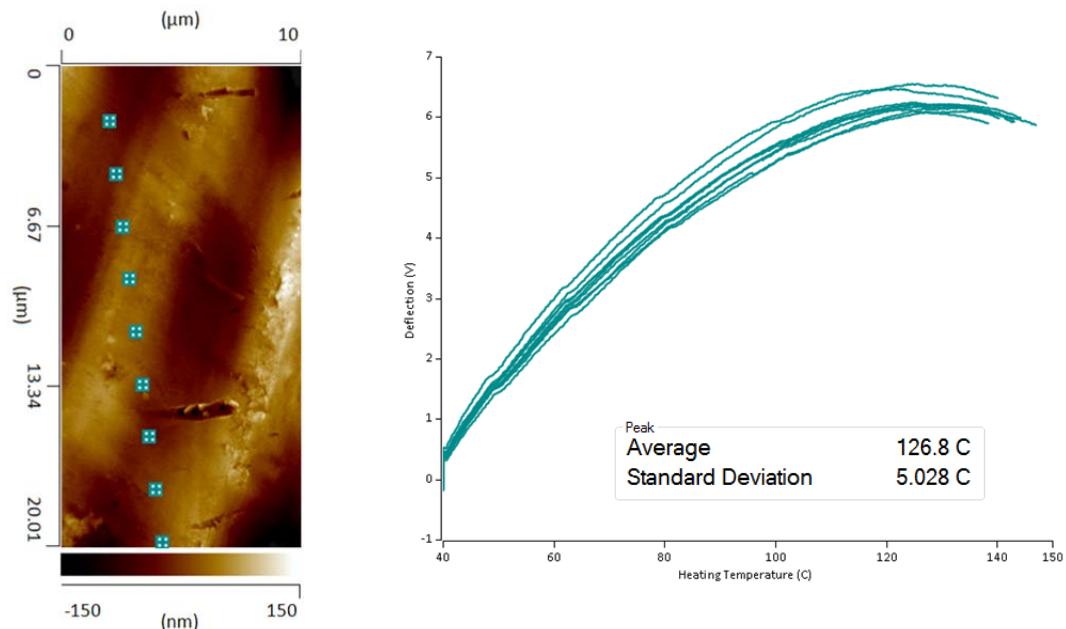
Figure 18 - AFM height image showing surface topography of Bellew, Dianne B fibers in region away from cracks (left). nanoTA measurements obtained away from the cracked regions on Bellew, Dianne B fibers (right).

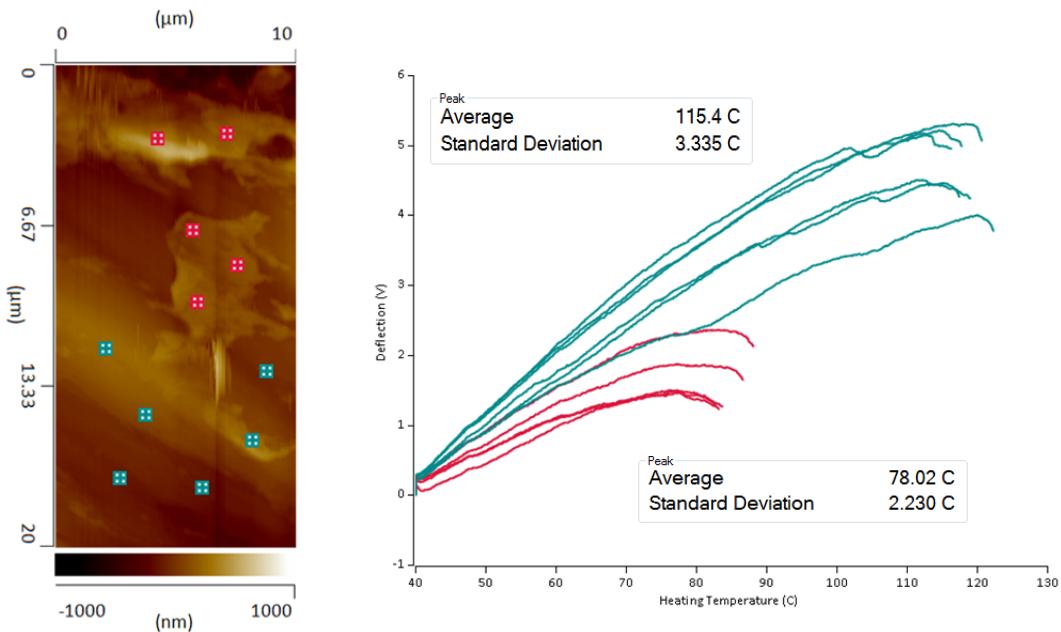
Figure 19 - AFM height image of surface of hypochlorite treated Bellew, Dianne C (left). nanoTA measurements on Bellew, Dianne C both on (red) and off (blue) the flake-like material (right).
